#### CALIFORNIA STATE UNIVERSITY MARITIME ACADEMY **ADMINISTRATION BUILDING** HAZARDOUS MATERIALS SURVEY

This is a quick reference summary of a survey completed by Vista Environmental in January 2023. The complete report is available by contacting EH&S at safety@csum.edu. If unsure about ANY information contact EH&S prior to impacting suspect material.

### CALIFORNIA STATE UNIVERSITY MARITIME ACADEMY ADMINISTRATION BUILDING HAZARDOUS MATERIALS SUMMARY

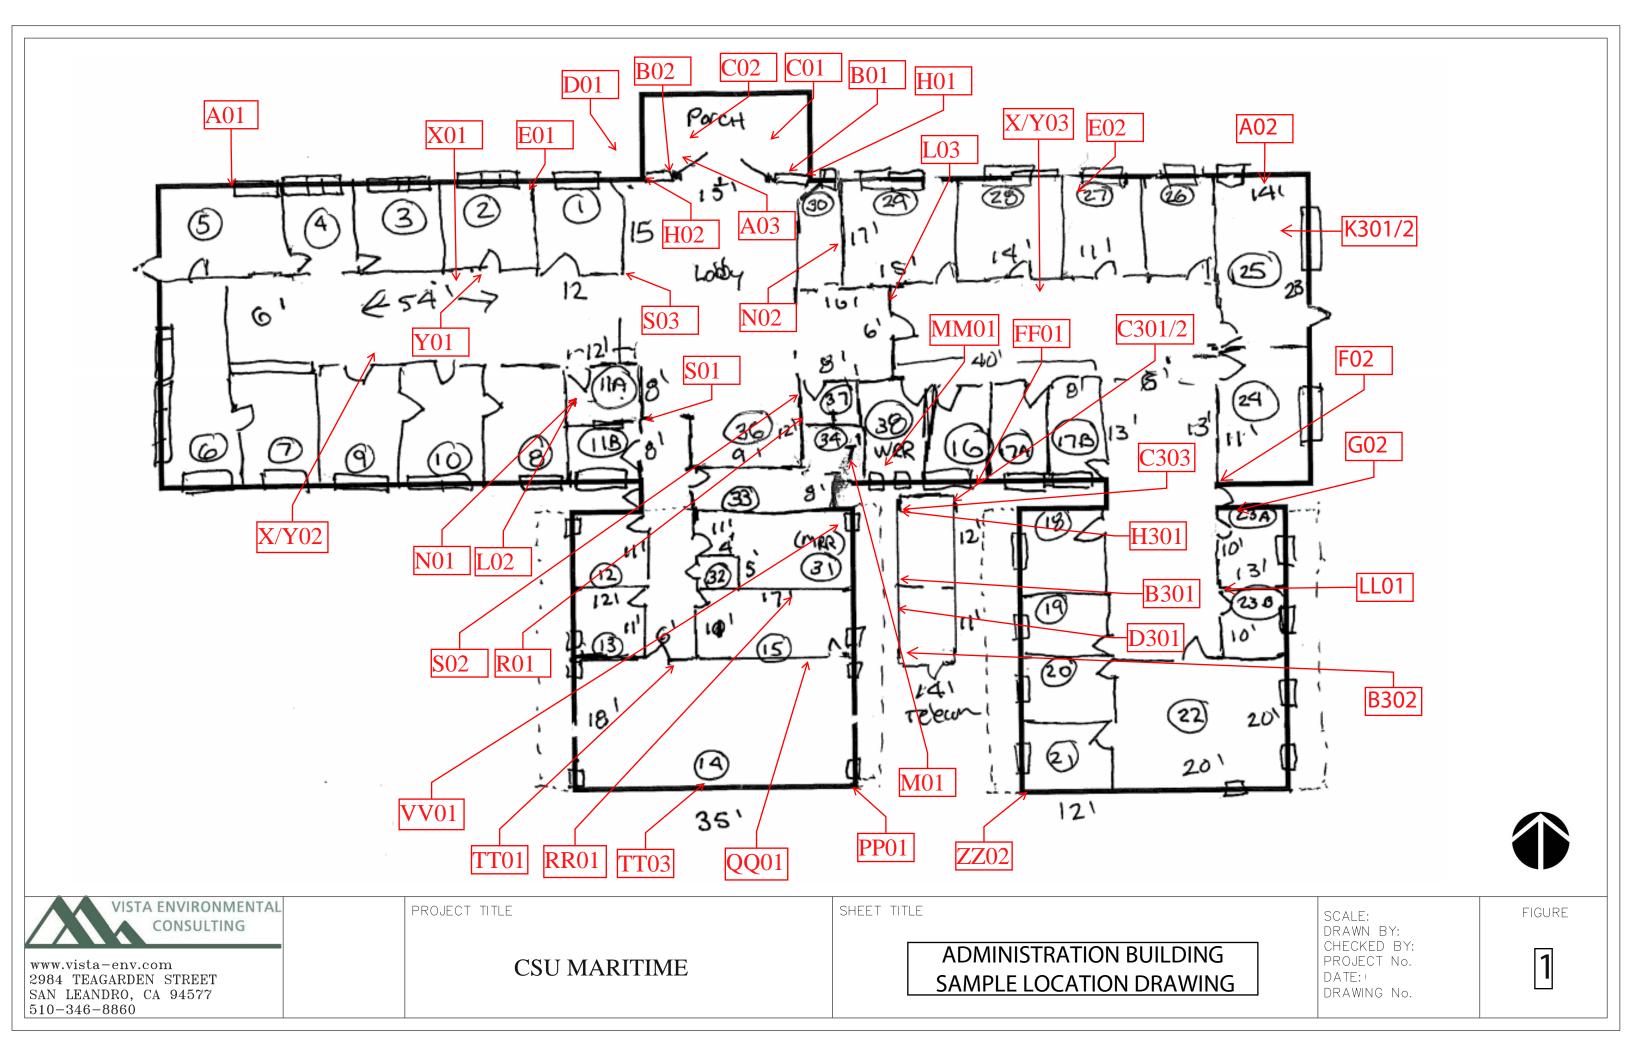
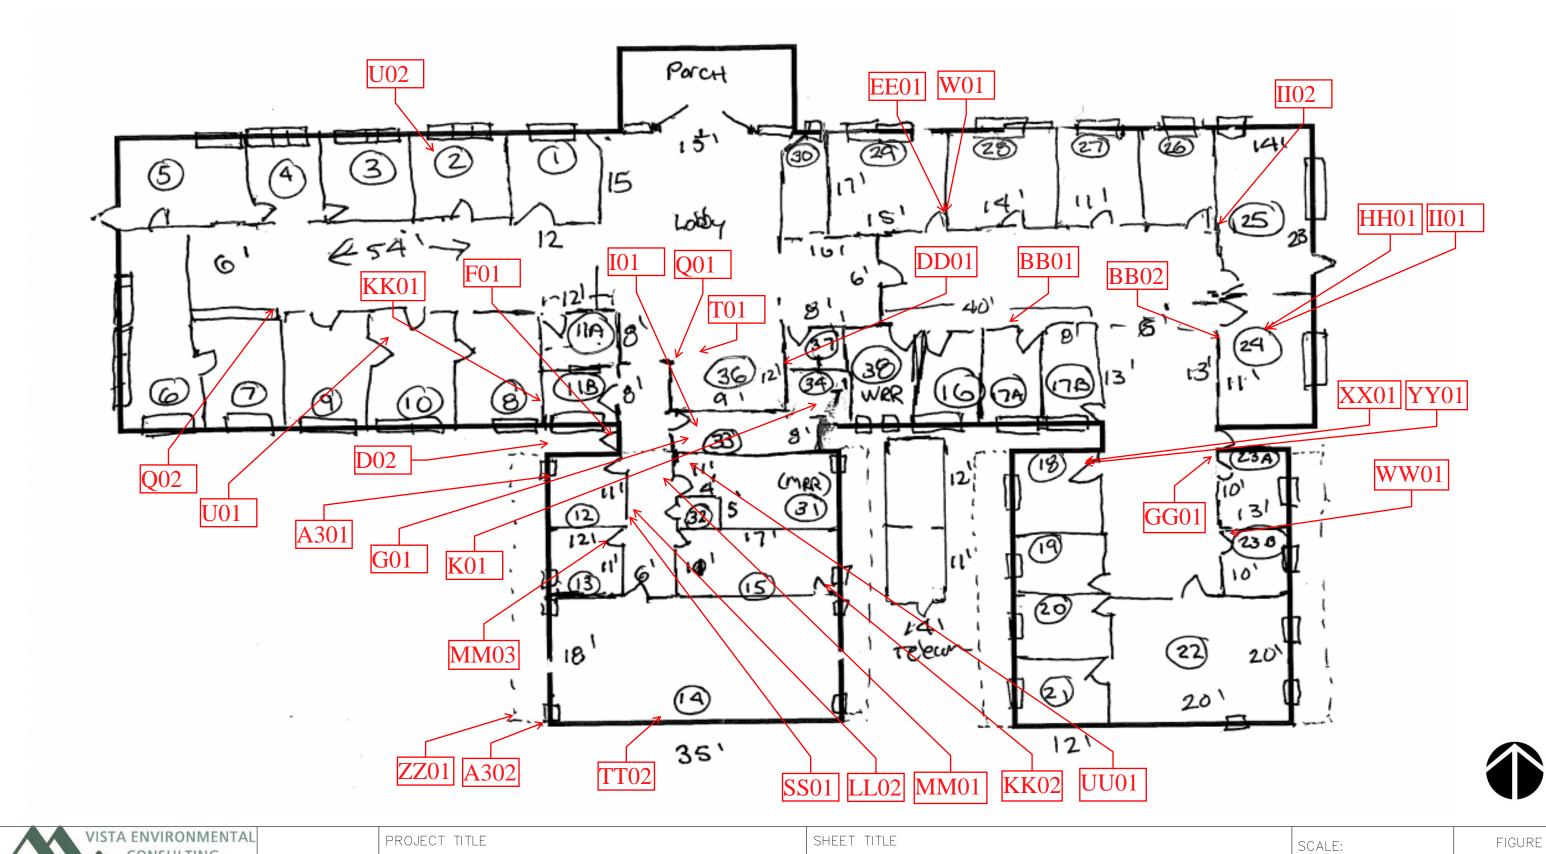
ADMINISTRATION BUILDING SAMPLE LOCATION DRAWING DRAWN BY: CHECKED BY: PROJECT No. DATE: DRAWING No.

The above list are ALL the materials sampled and tested for asbestos. The positive materials are in **red**. The non-detected for asbestos materials are in black. If you cannot positively identify the material you need to impact through the above inventory and the map showing the sample locations, do not disturb and contact EH&S for further sampling or guidance. The materials not listed were not sampled and must be assumed asbestos containing until proven not by testing.
