CALIFORNIA STATE UNIVERSITY MARITIME ACADEMY FACULTY OFFICE BUILDING HAZARDOUS MATERIALS SURVEY SUMMARY

This is a quick reference summary of a survey completed by Vista Environmental in October 2024. The complete report is available by contacting EH&S at safety@csum.edu. If unsure about ANY information contact EH&S prior to impacting suspect material.

**CALIFORNIA STATE UNIVERSITY MARITIME ACADEMY
ADMINISTRATION BUILDING
HAZARDOUS MATERIALS SURVEY**

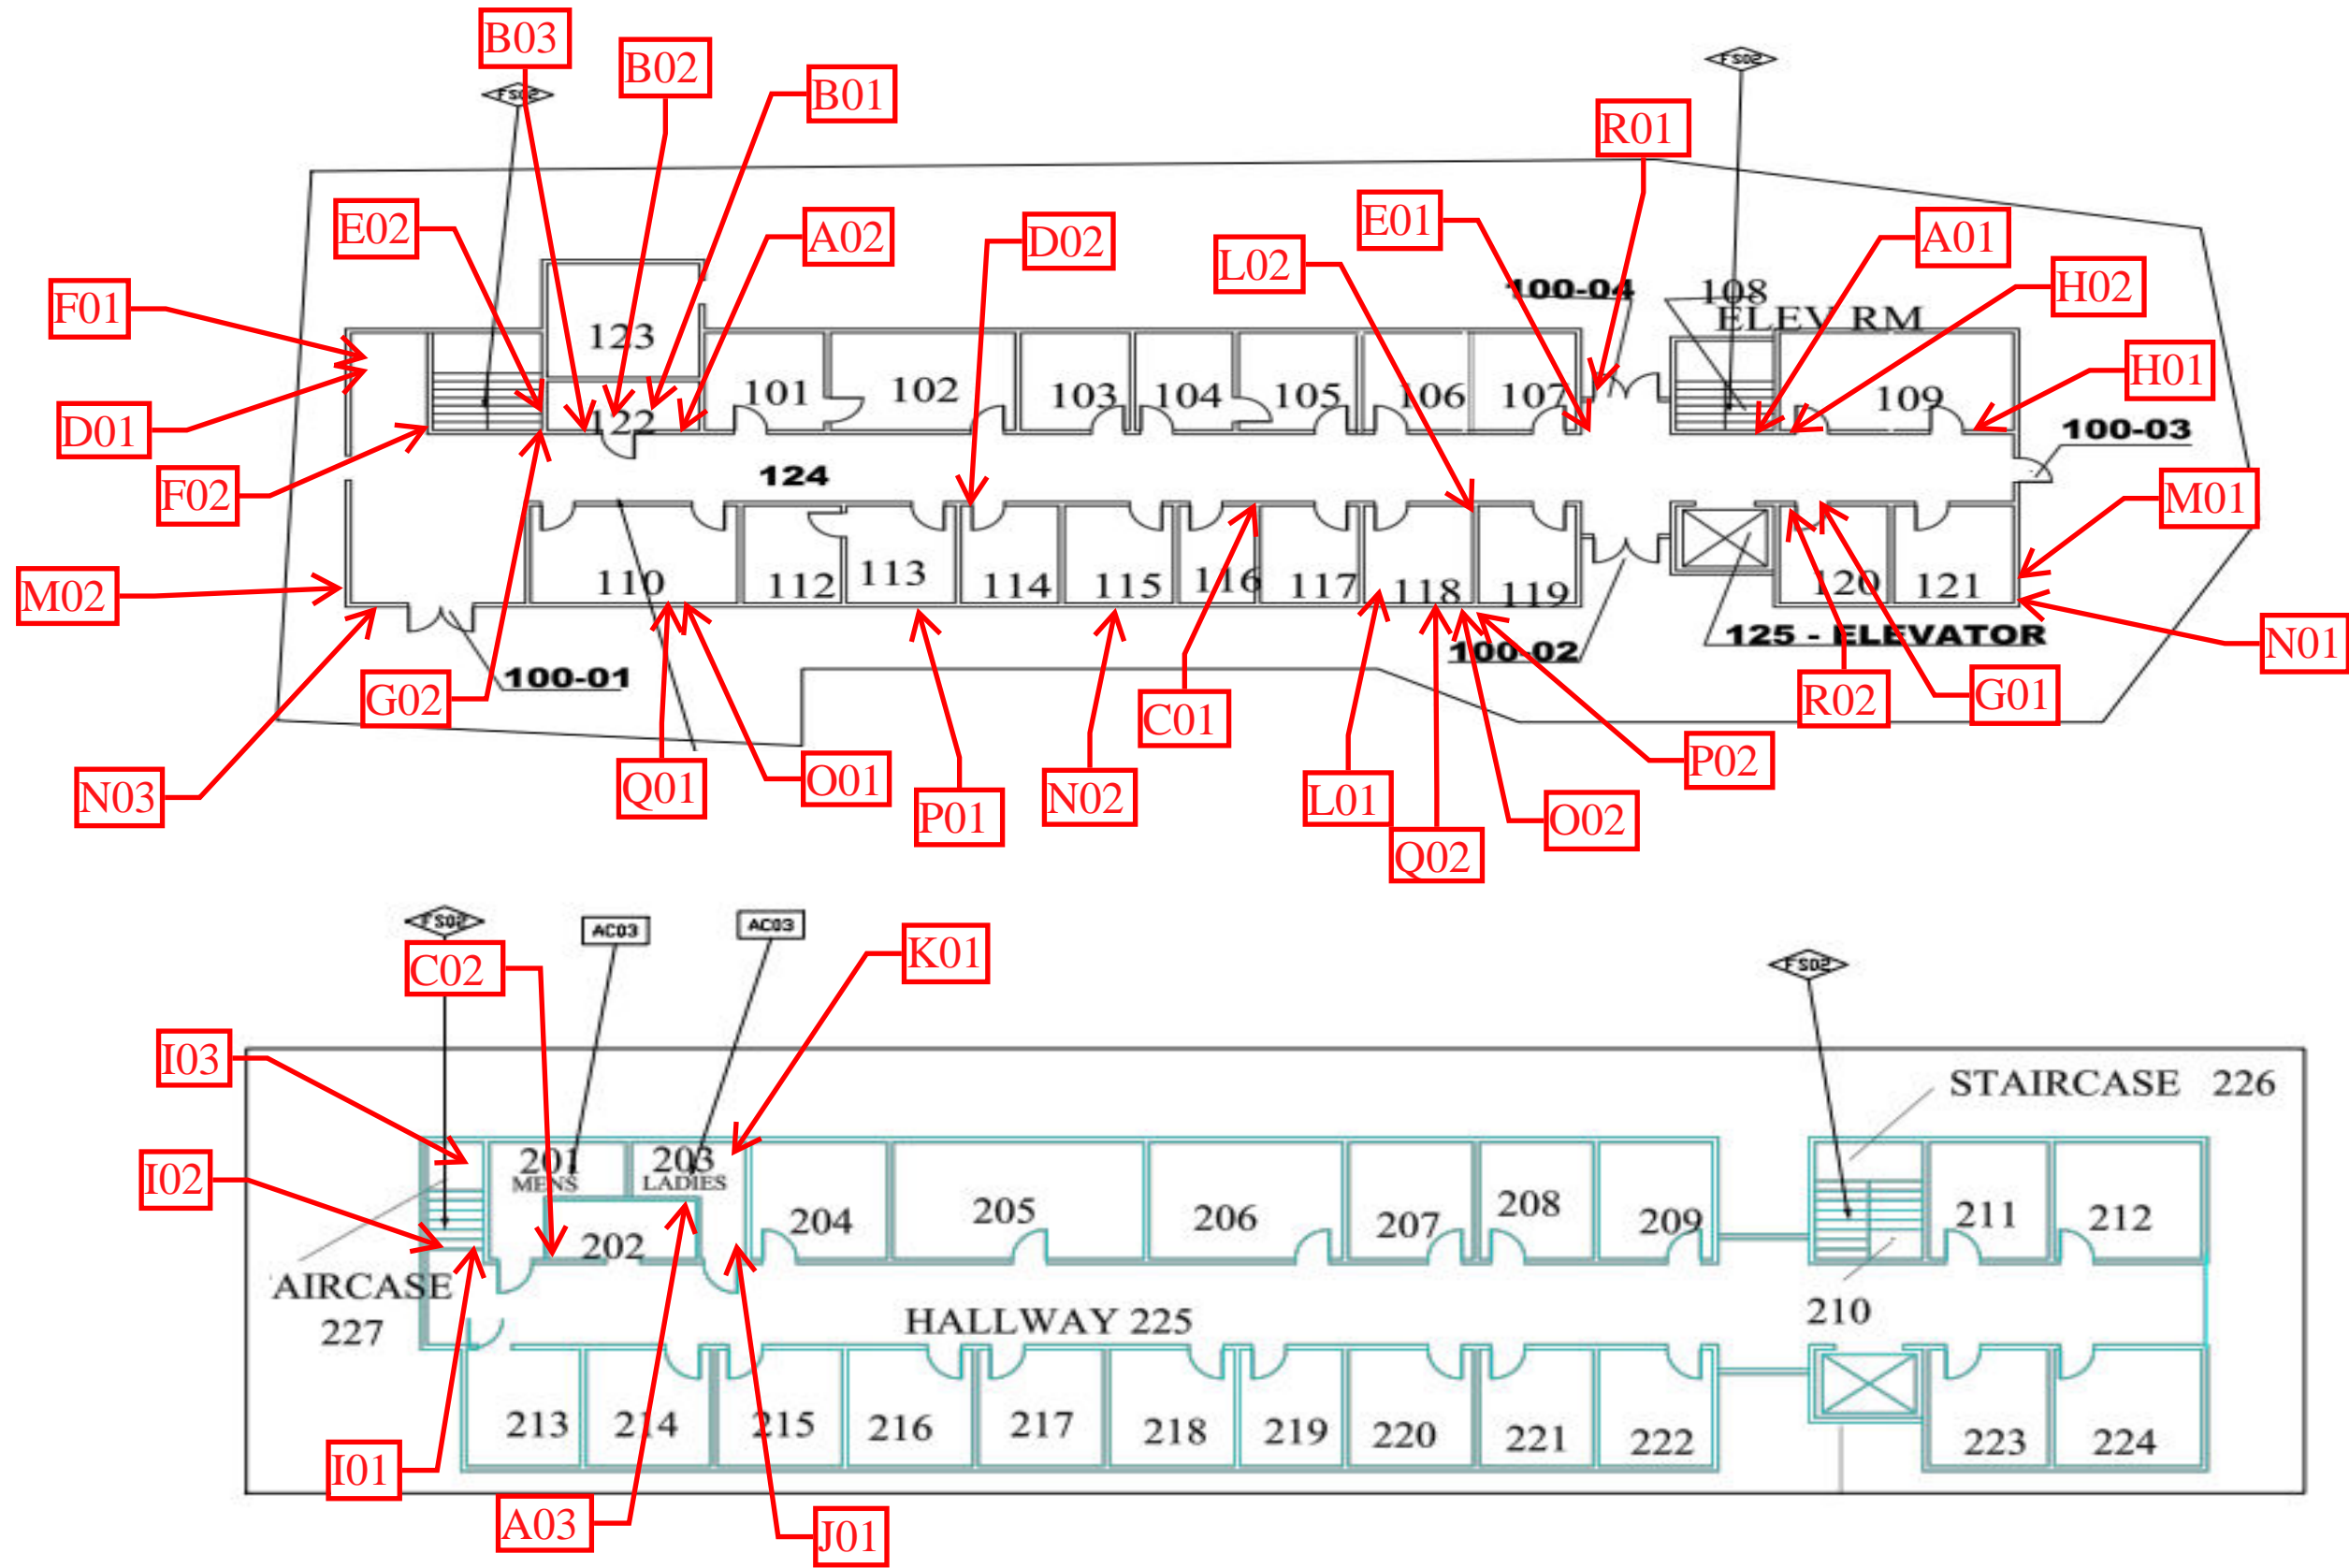
Positive Asbestos

HOMO ID	MATERIAL	DESCRIPTION	LOCATION	CAL/OSHA CLASS	BAAQMD CATEGORY
A	Wallboard/Joint Compound	White/White	Throughout Walls and Ceilings	Class II	Friable (RACM when Removed)
B	Texture Coat	White, Medium, Ceiling	Room 122 Ceiling	Class II	Friable (RACM when Removed)
D	Vinyl Floor Tile/Mastic	12" White, Black Streaks/Black	Throughout Except Restrooms, Stairways, First Floor Hallway East and West, Rooms 101, 104,108, 109A, 109B, 118, 122, and 123.	Class II	Category I - Non-Friable
G	Vinyl Floor Tile/Mastic	12" Gray, White Streaks/Yellow & Brown	First Floor Hallway East and West	Class II	Category I - Non-Friable
H	Vinyl Floor Tile/Mastic	12" White, Beige Streaks/Yellow & Brown	Rooms 101, 104, 109A, and 109B	Class II	Category I - Non-Friable
I	Texture Coat	White, Small Ceiling	Second Floor Staircase 227 Ceiling	Class II	Friable (RACM when Removed)
L	Vinyl Floor Tile/Mastic	12" White, Black Specs/Yellow & Black	Room 118	Class II	Category I - Non-Friable

P	Sealant	Black, Window Frames	Exterior Dark Aluminum Window Frames and Store Front	Class II	Category I - Non-Friable
