**CALIFORNIA STATE UNIVERSITY MARITIME ACADEMY  
LIBRARY  
HAZARDOUS MATERIALS SURVEY SUMMARY**

**This is a quick reference summary of a survey completed by Vista Environmental in October 2024. The complete report is available by contacting EH&S at [safety@csum.edu](mailto:safety@csum.edu). If unsure about ANY information contact EH&S prior to impacting suspect material.**

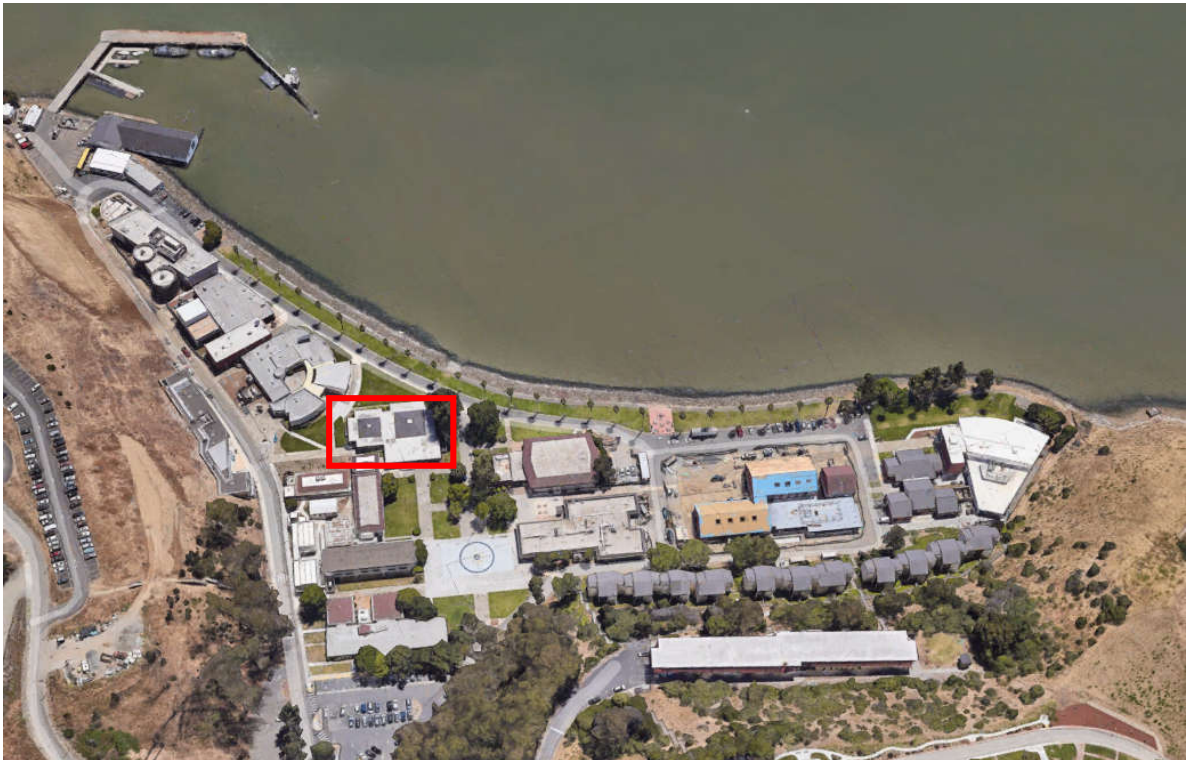
Sampled for **asbestos** and **detected**  
Sampled for **lead** and **detected**

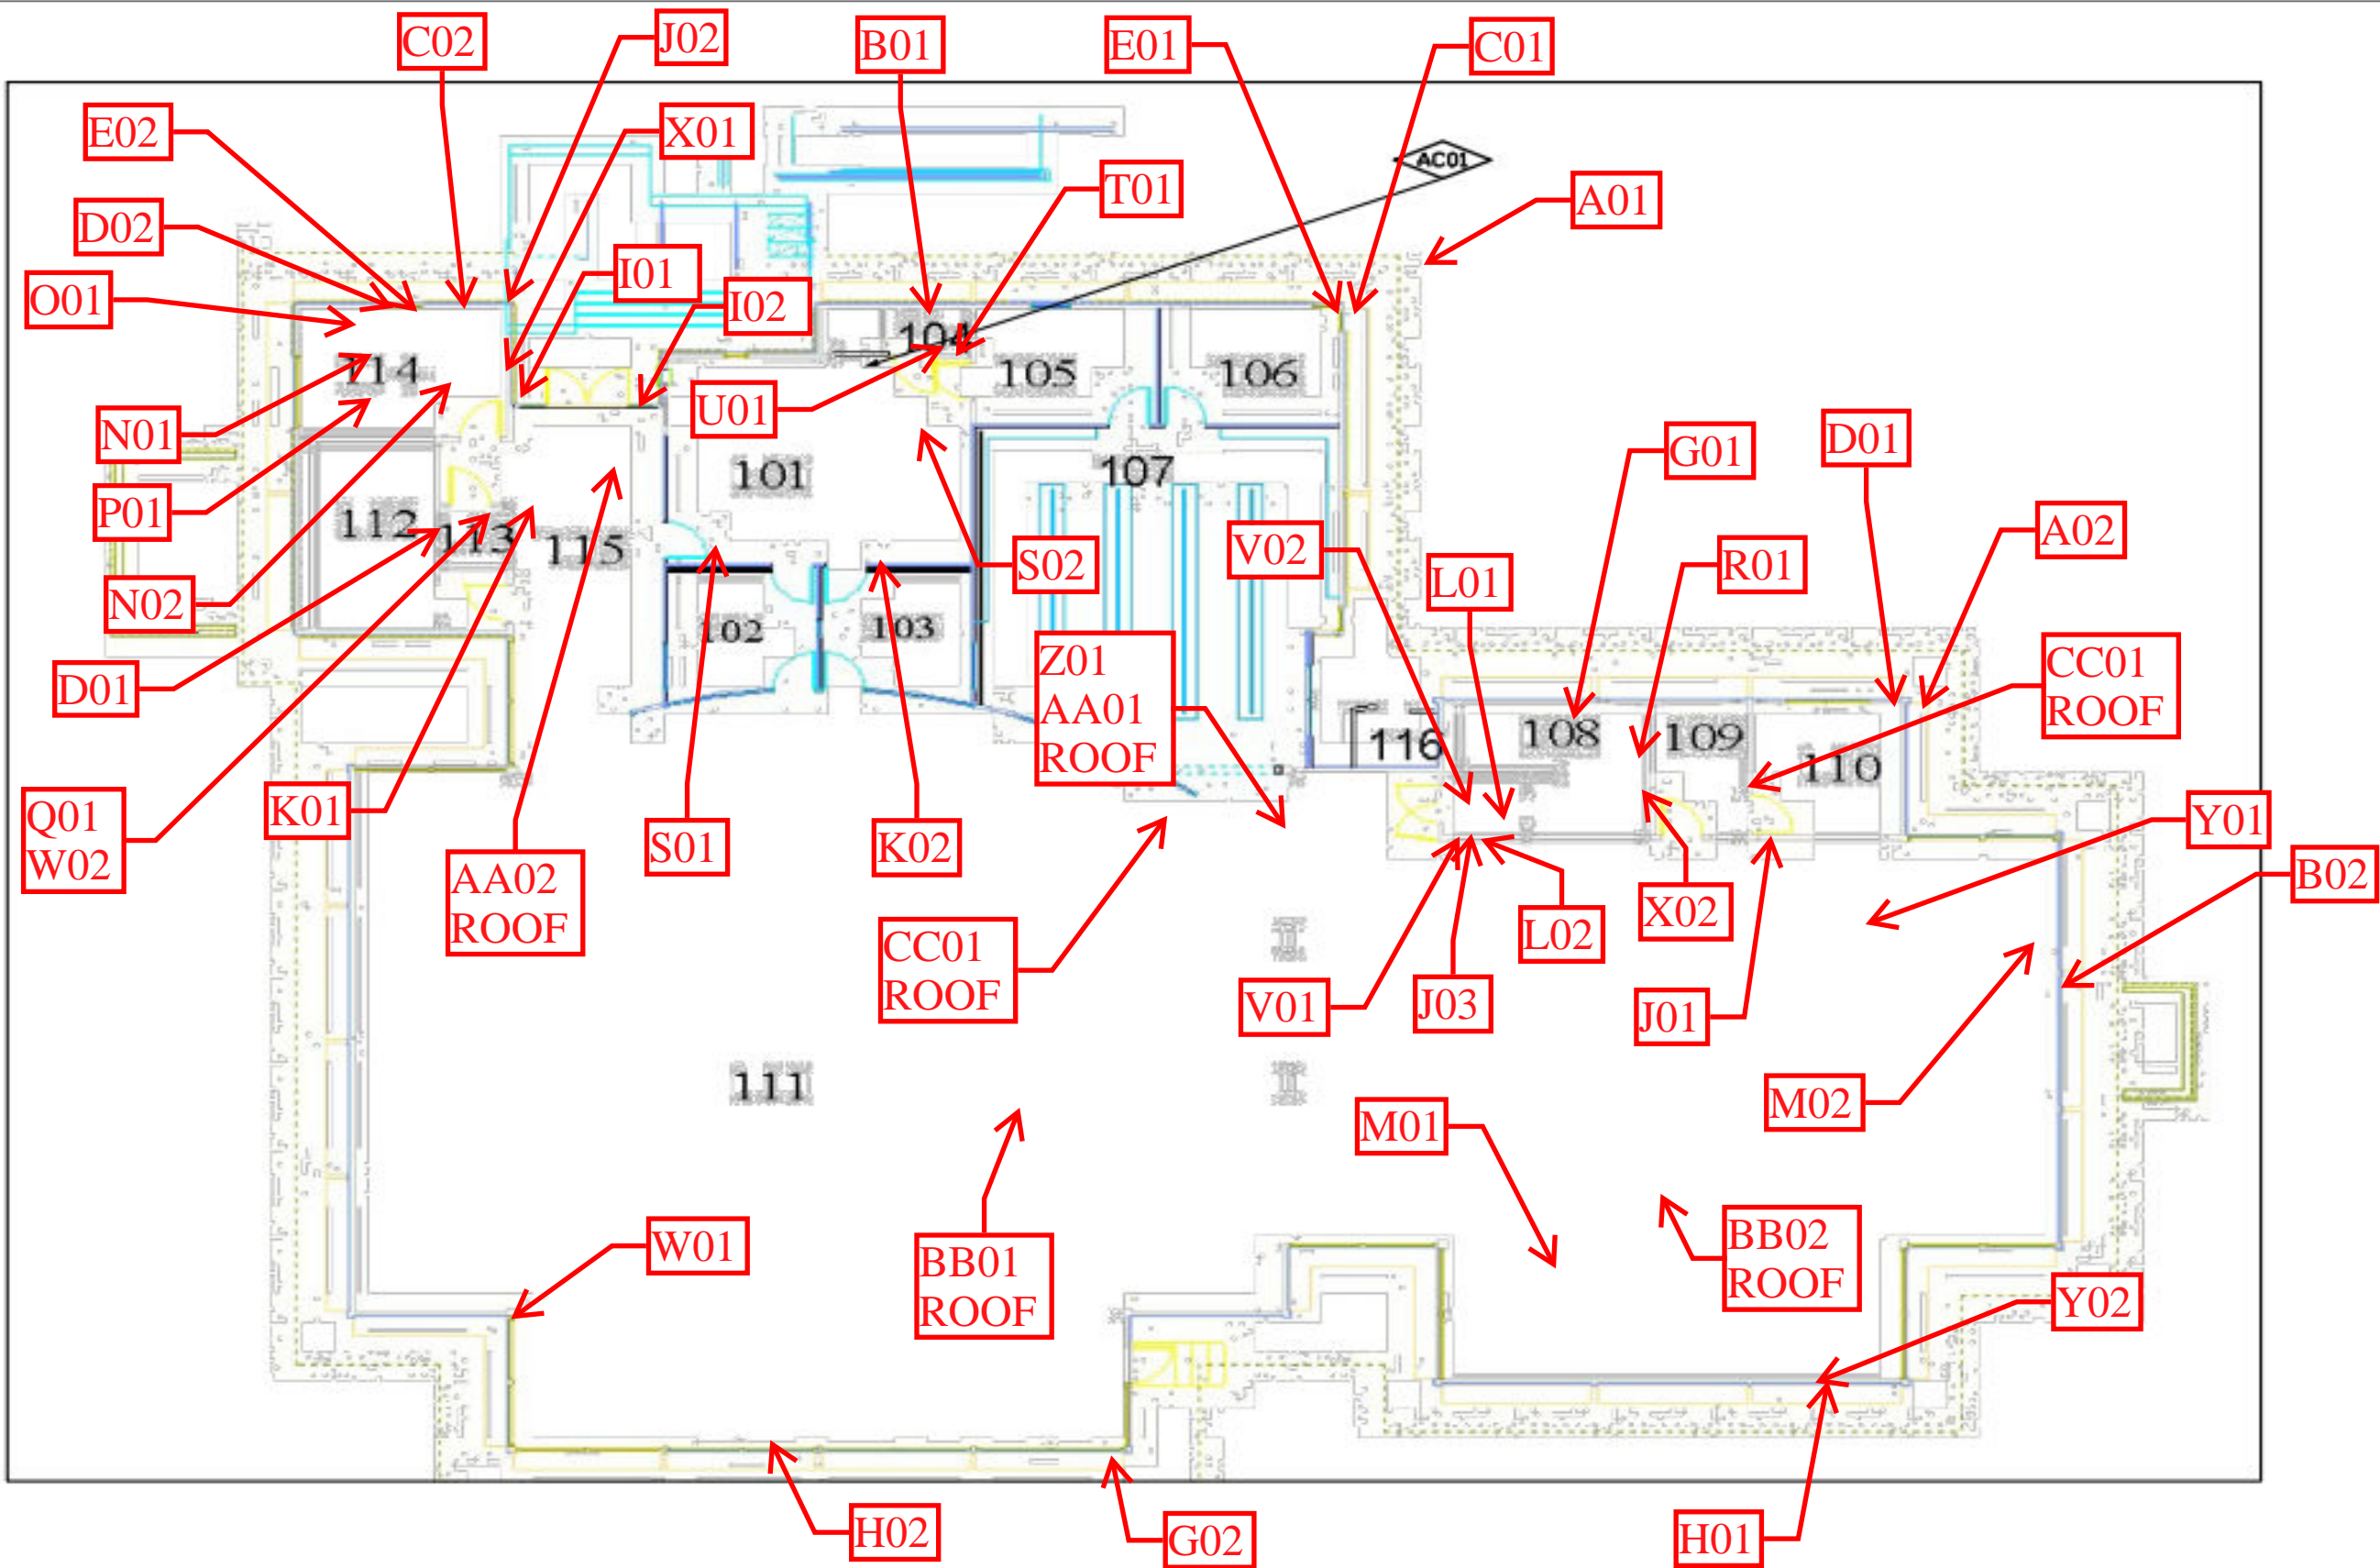
***XRF Positive Lead Locations***

ROOM	COMPONENT	SUBSTRATE	COLOR	CONDITION	Pb	UNITS
Outside	Post	Wood	Dark Brown	Intact	0.1	mg/cm <sup>2</sup>
Outside	Post	Wood	Dark Brown	Intact	0.1	mg/cm <sup>2</sup>
Outside	Beam	Wood	Dark Brown	Intact	0.2	mg/cm <sup>2</sup>
Outside	Beam	Wood	Dark Brown	Intact	0.2	mg/cm <sup>2</sup>
Outside	Soffit	Wood	Dark Brown	Intact	0.2	mg/cm <sup>2</sup>
Outside	Fascia	Metal	Dark Brown	Intact	0.1	mg/cm <sup>2</sup>
Outside	Fascia	Metal	Dark Brown	Intact	0.1	mg/cm <sup>2</sup>
Outside	Lower Wall	Wood	Beige	Intact	0.1	mg/cm <sup>2</sup>
Outside	Lower Wall	Wood	Dark Brown	Intact	0.1	mg/cm <sup>2</sup>
Outside	Lower Wall	Wood	Dark Brown	Intact	0.1	mg/cm <sup>2</sup>
Outside	Lower Wall	Concrete	Beige	Intact	0.1	mg/cm <sup>2</sup>
Outside	Lower Wall	Concrete	Beige	Intact	0.1	mg/cm <sup>2</sup>
Outside	Vent	Metal	Beige	Intact	0.3	mg/cm <sup>2</sup>
Outside	Vent	Metal	Beige	Intact	0.1	mg/cm <sup>2</sup>
Outside	Downspout	Metal	Dark Brown	Intact	0.2	mg/cm <sup>2</sup>
