CALIFORNIA STATE UNIVERSITY MARITIME ACADEMY  
LOWER RESIDENCE C

This is a quick reference summary of a survey completed by Vista Environmental in January 2023. The complete report is available by contacting EH&S at [safety@csum.edu](mailto:safety@csum.edu). If unsure about ANY information contact EH&S prior to impacting suspect material

**CALIFORNIA STATE UNIVERSITY MARITIME ACADEMY  
LOWER RESIDENCE C  
HAZARDOUS MATERIALS SUMMARY**

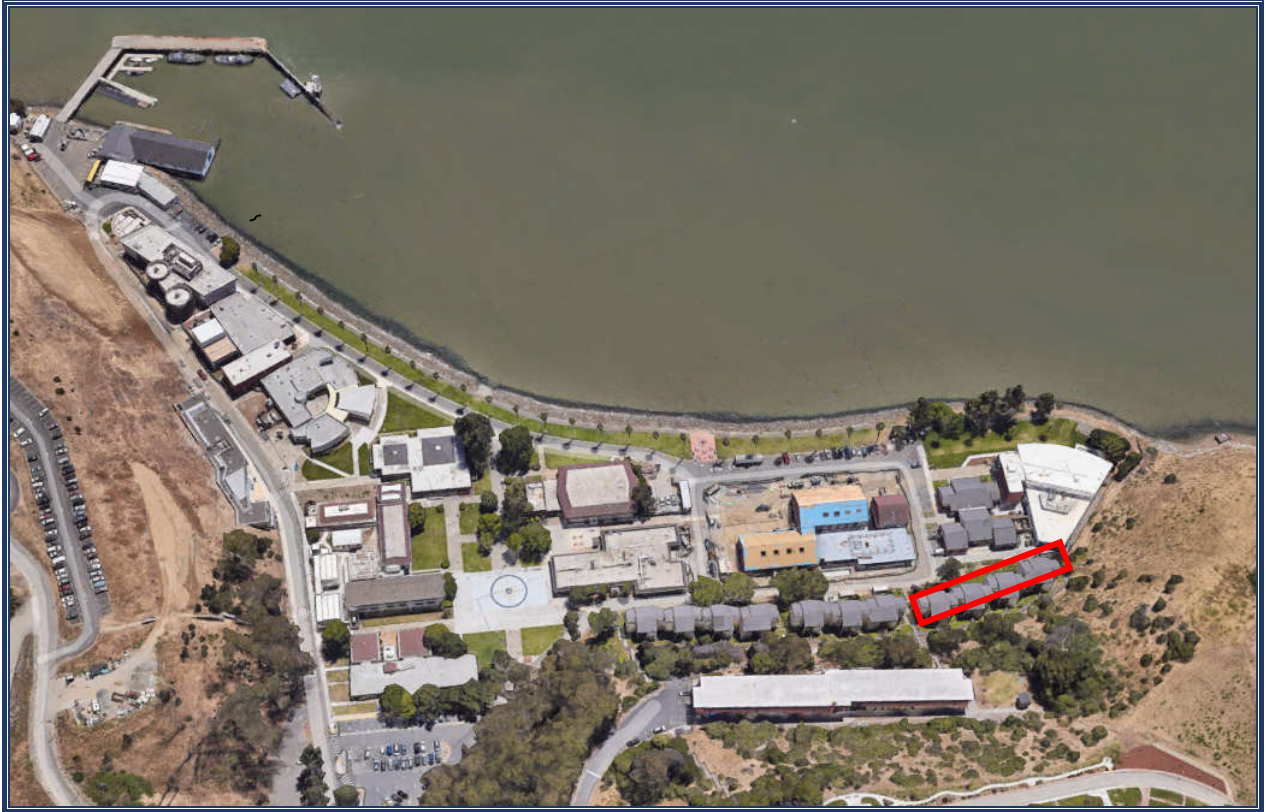
Sampled for **asbestos** and **detected**  
Sampled for **lead** and **detected**
